Manhole Inspection Summary

Manhole # S29S__008MH

Location Address: **Russell St.**

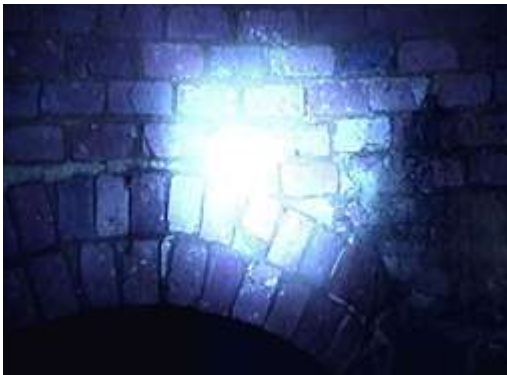
Additional Image of Pipe In @ 6 OClock

couldnt get whole pipe in one shot

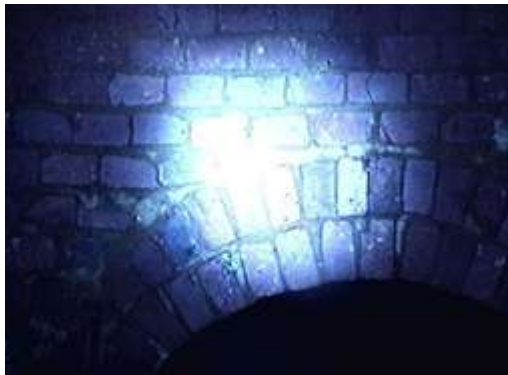
Additional Image of Pipe In @ 6 OClock

couldnt get whole pipe in one shot

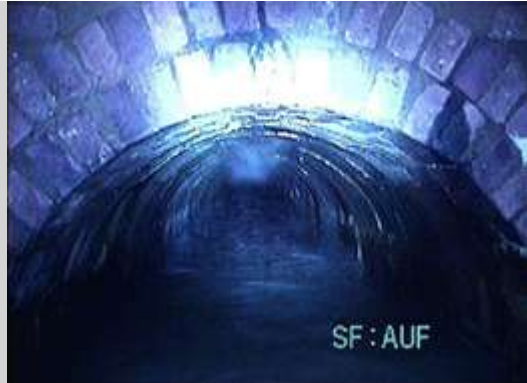
12 O'Clock Outflow

Pipe Height: **36** (in.) Rod and Bar (Angled)
Pipe Material: **Clay** ☐ Pipe Lined
Invert Depth: **18.33** (ft.) Flow Characteristics: **Slow**
Deposits: ☒ None ☐ Mud ☐ Sludge ☐ Debris ☐ Grease
Silt Depth: **0** (in.) Deposits Extent:
Infiltration: **None** Pipe Seal Cond: **Sound**

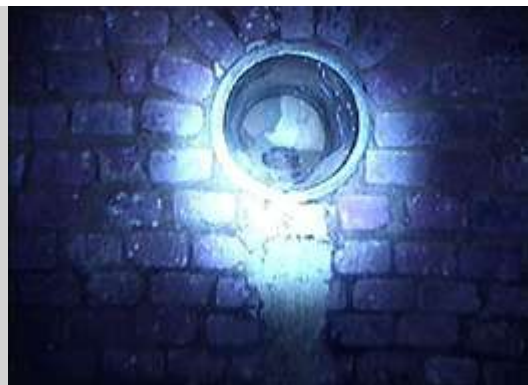
9 O'Clock Inflow

Pipe Height: **9.6** (in.) Rod and Bar (Angled)

Pipe Material: **Clay** ☐ Pipe Lined

Infiltration: **None**
